Field report for the December 2004 earthquakes in Nador, Morocco.

Patrick Murphy Corella Architect, Calle Piamonte 18, 28004 Madrid, Spain +34 696 22 69 73
alhaquen@tiscali.es

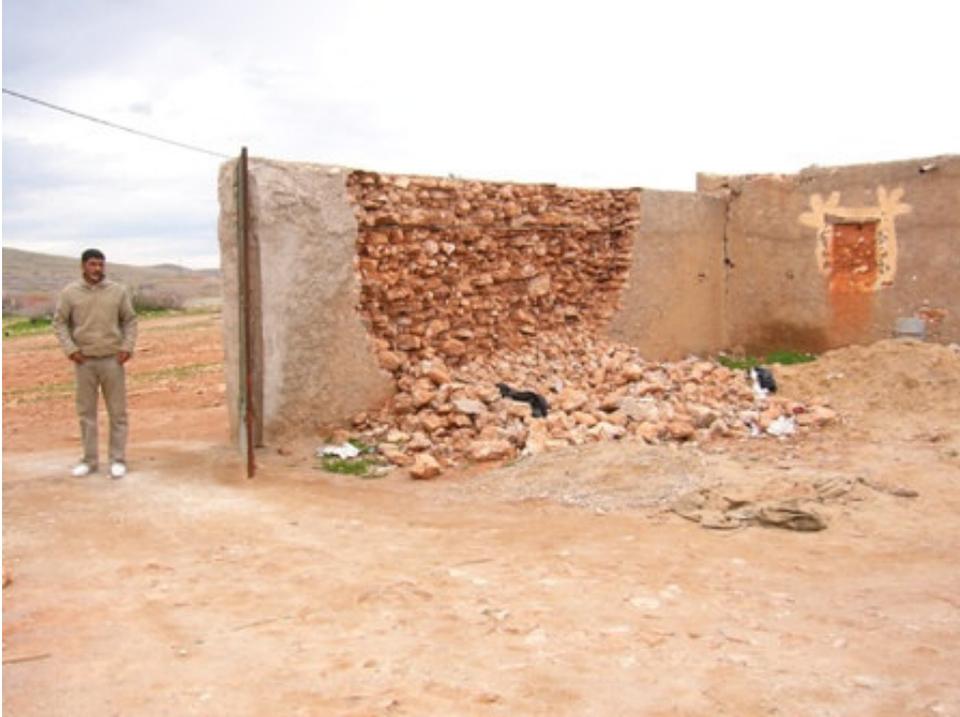
Loss of the outer leaf of a wall in Douria. Grade 3 vulnerability A

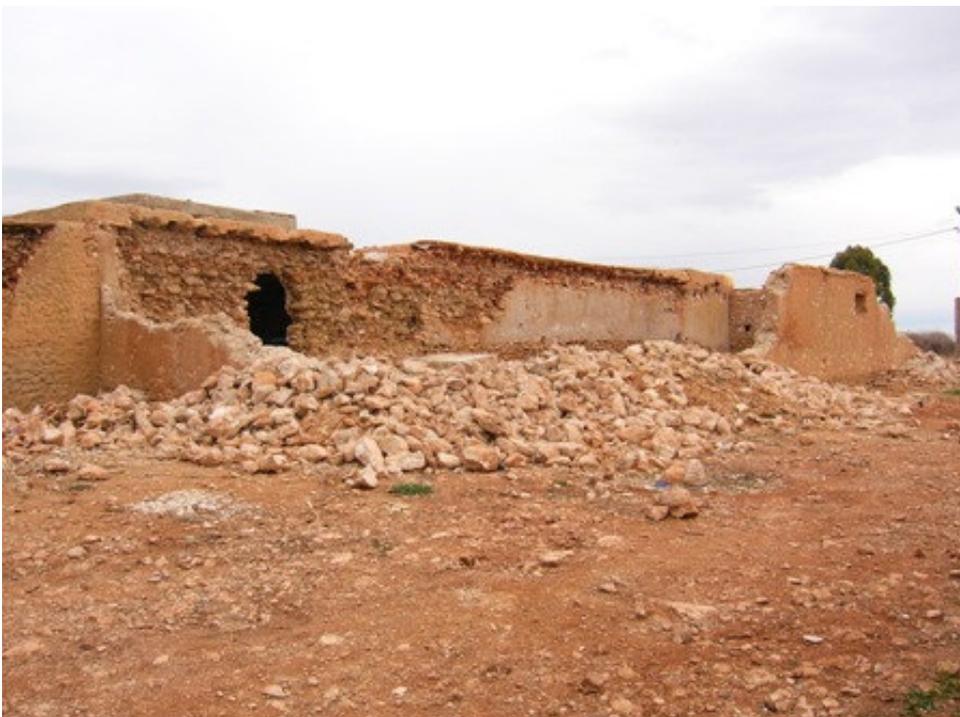
Loss of the outer leaf of a wall and failure of freestanding stone wall in Douria. Grade 3 vulnerability A

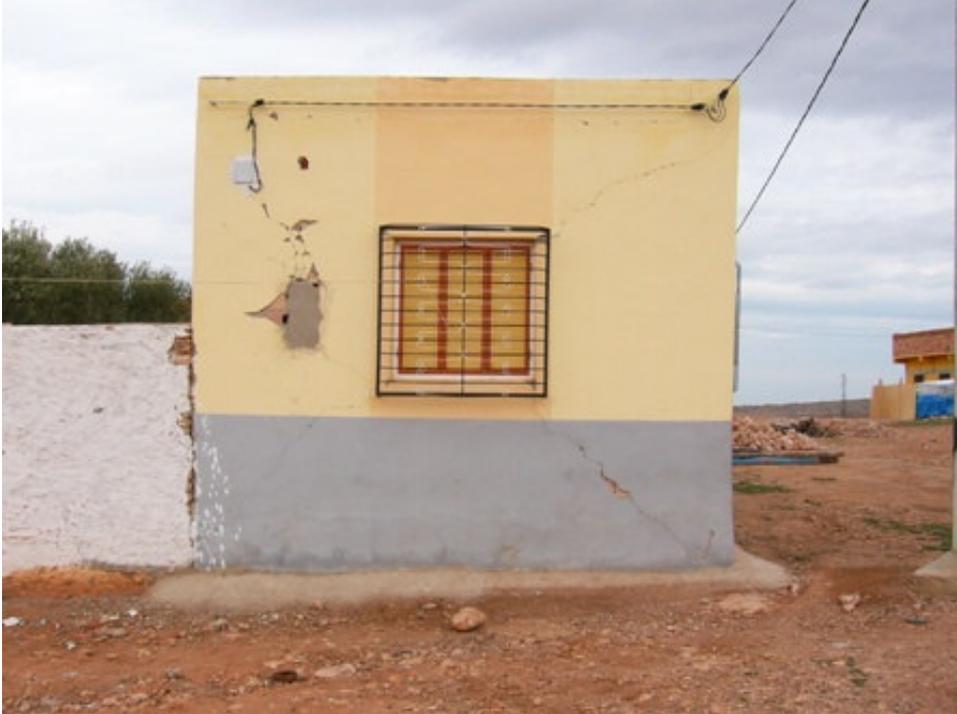
X shear crack in Douria. Grade 2 vulnerability B

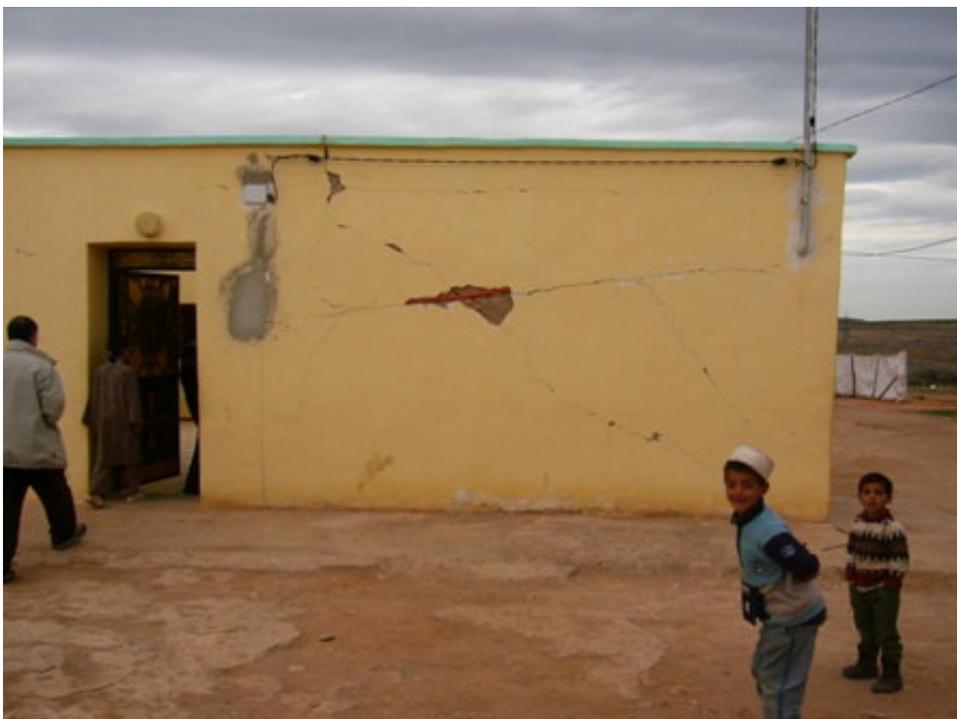
X shear crack in Douria. Note the vulnerability caused by the existing conduit in the wall. Grade 2 vulnerability B

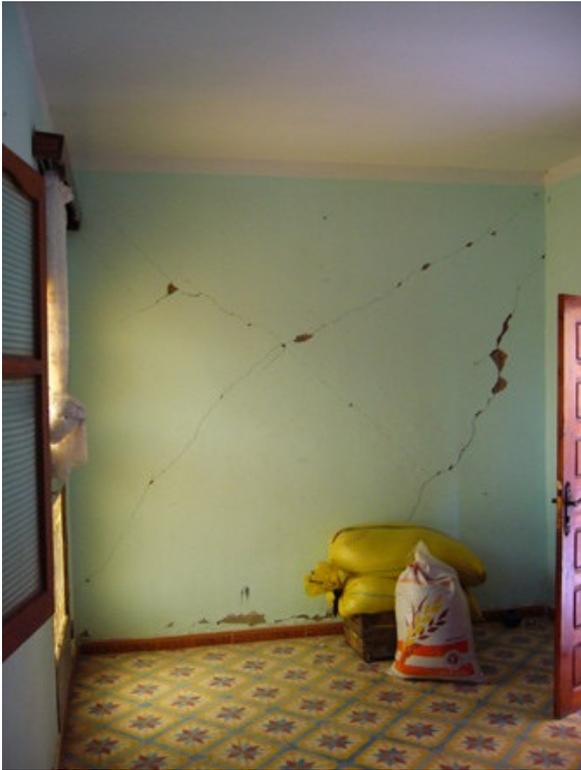
Inside view of crack shown above. Grade 2 vulnerability B

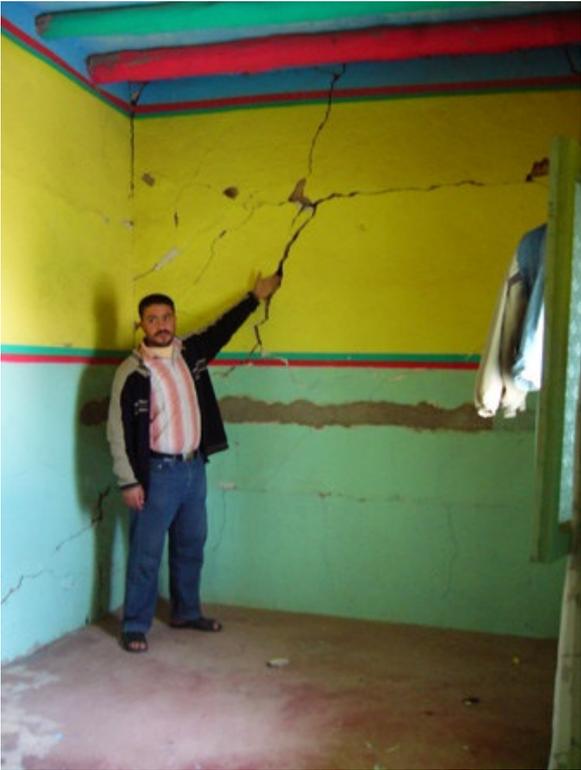
Shear crack in Douria

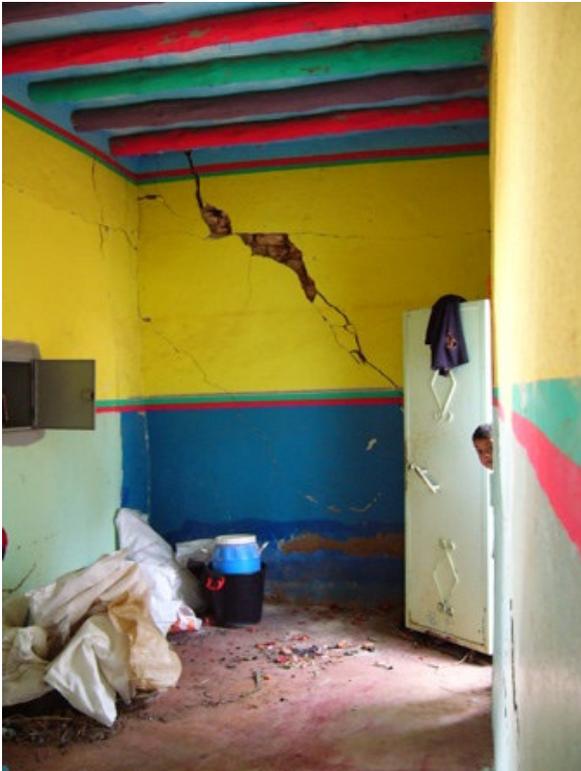
Shear crack in same room in Douria

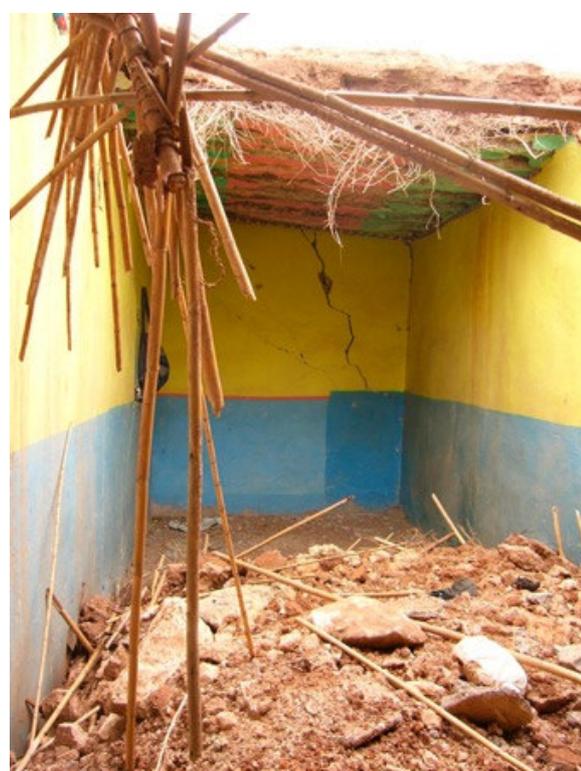
Crack shown above seen from another room with a collapsed previously weakened roof. Final diagnosis is grade 3 vulnerability A

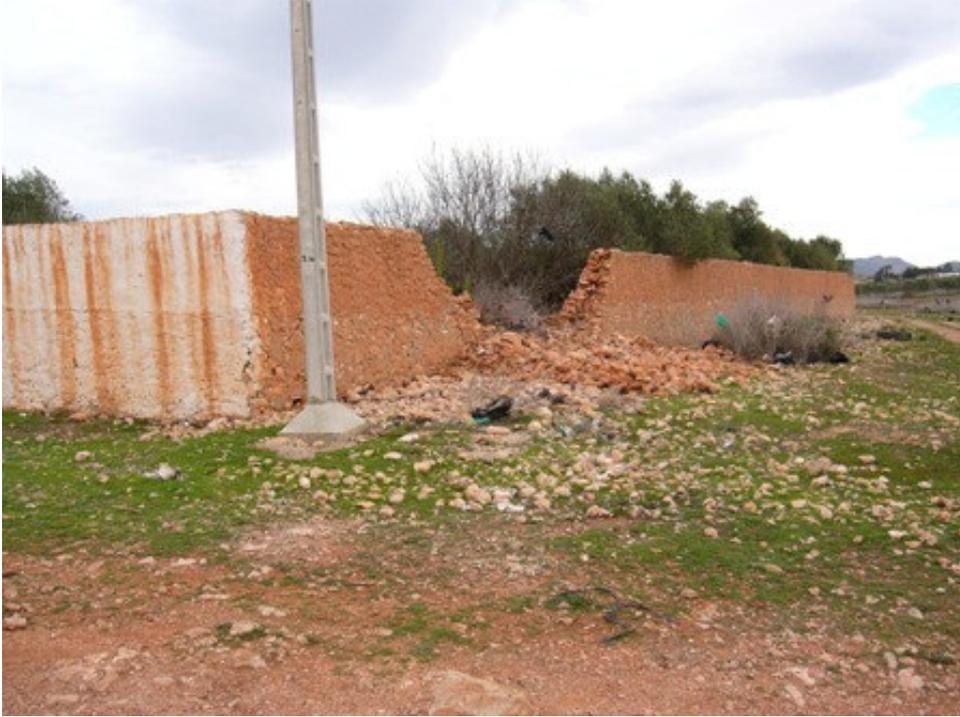
Failed unsupported wall in Douria. This is grade 3 vulnerability A

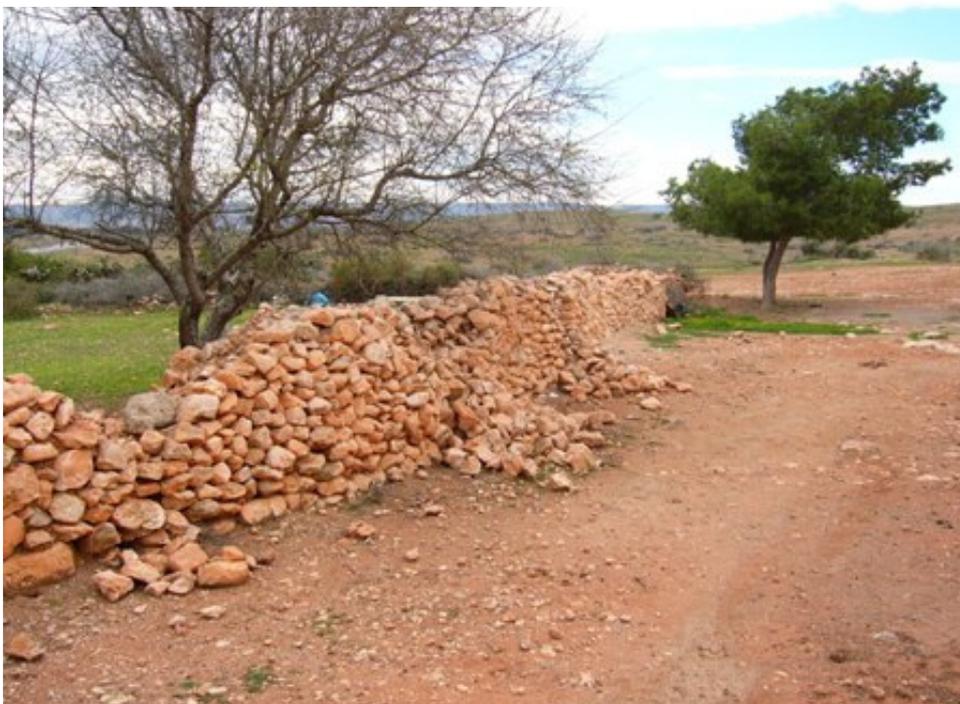
Failed dry stone walling in a homestead NW of Douria

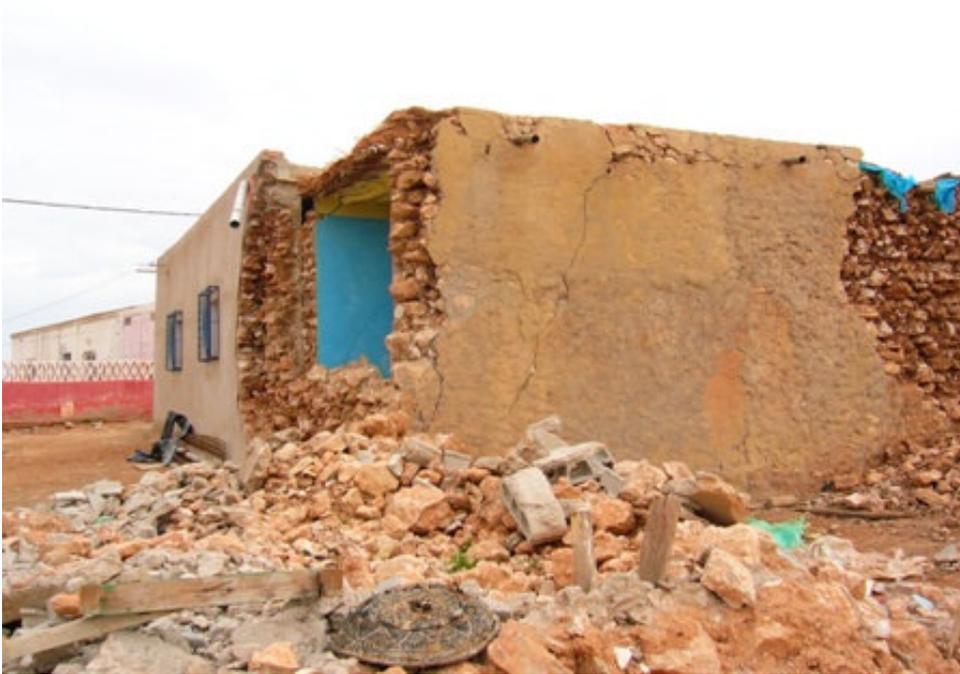
Failed corner and gable wall. Grade 3 vulnerability A

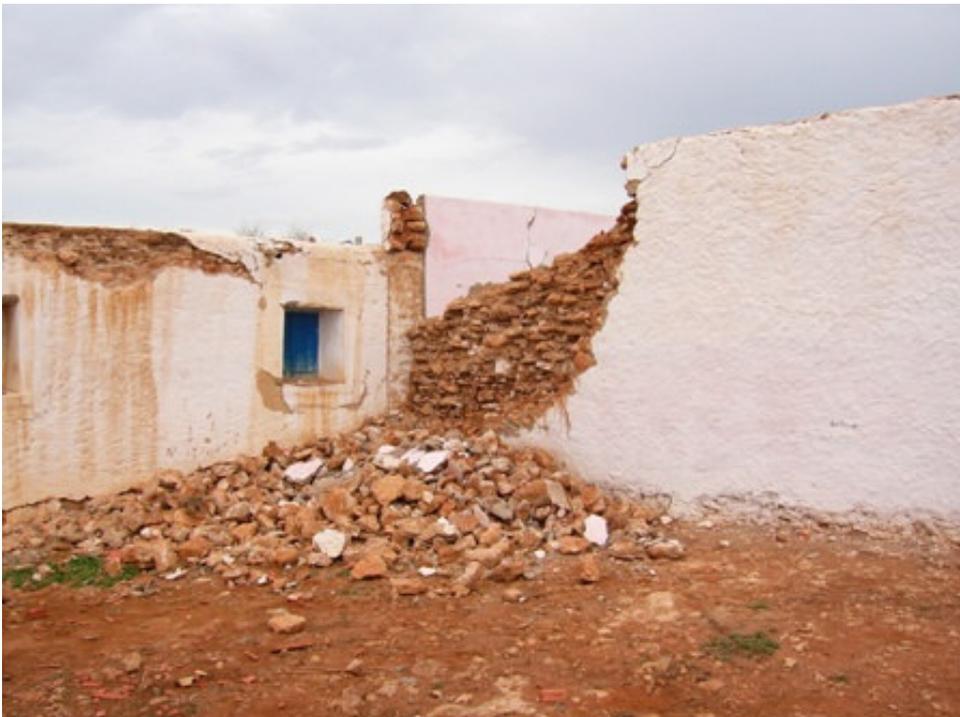
Failed corner. Grade 3 vulnerability A

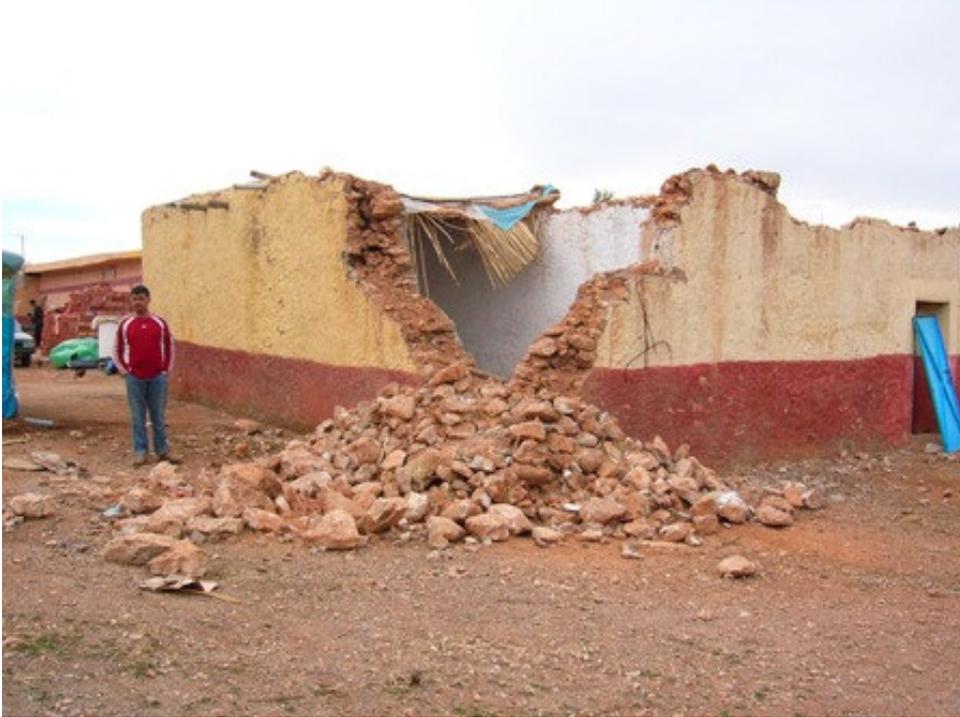
Failed corner and serious damage to roof and walls. Grade 4 vulnerability A

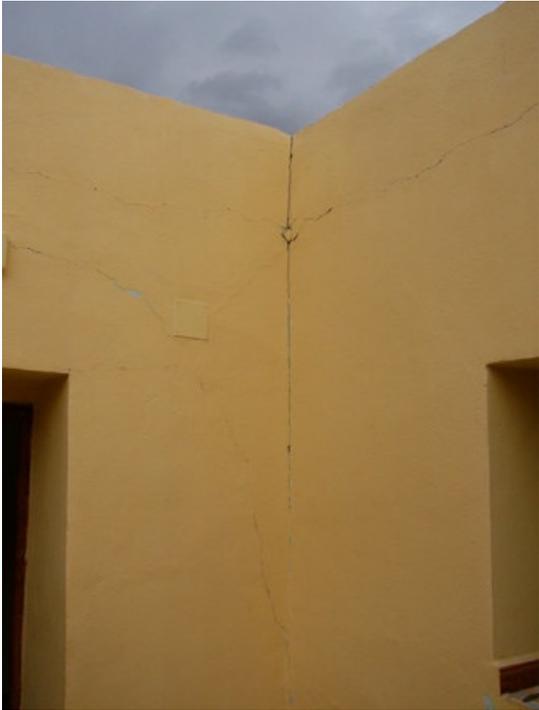
Slight loss of connection in bearing walls. Grade 2 vulnerability B

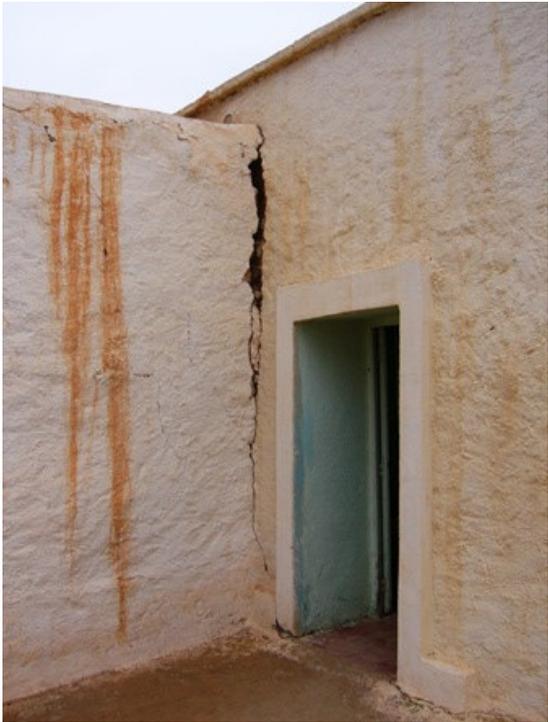
Moderate loss of connection in bearing walls. Grade 3 vulnerability A

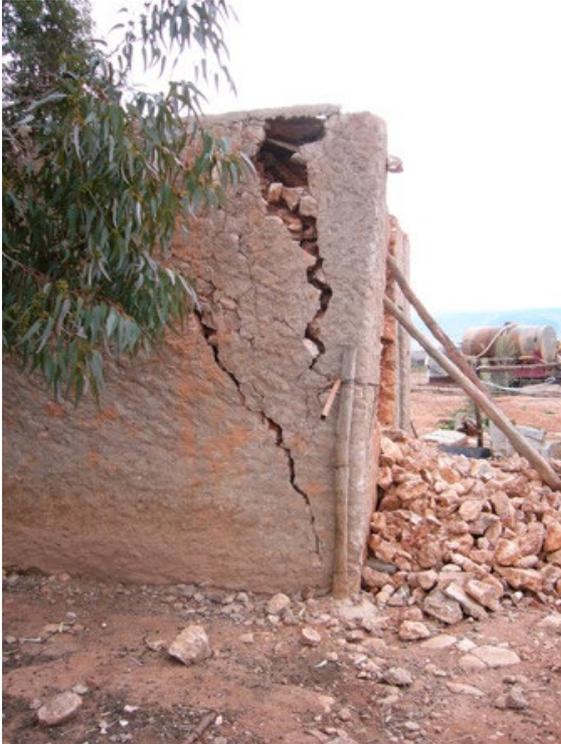
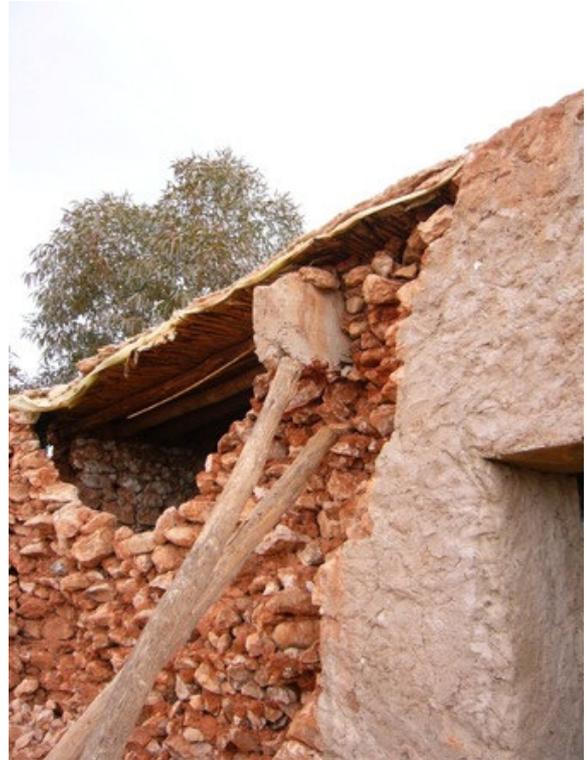
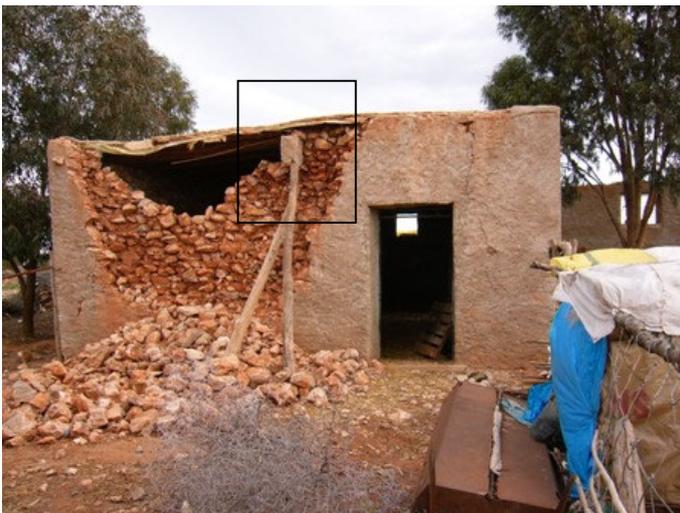
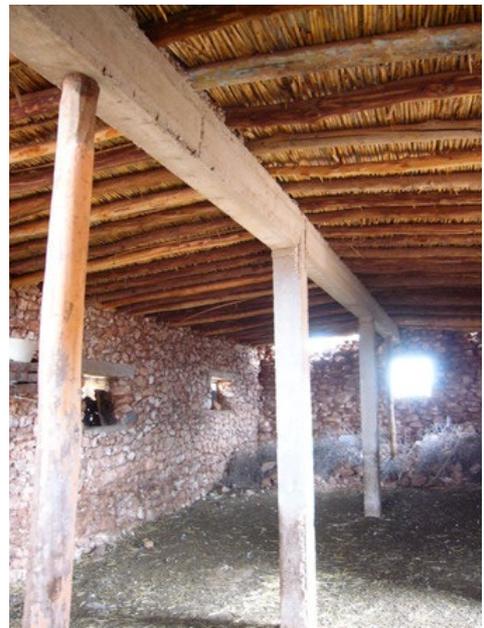
Four views of a damaged composite farm structure with a large concrete beam simply supported on fieldstone bearing walls. Motion of the beam punched the wall out. Grade 3 vulnerability A

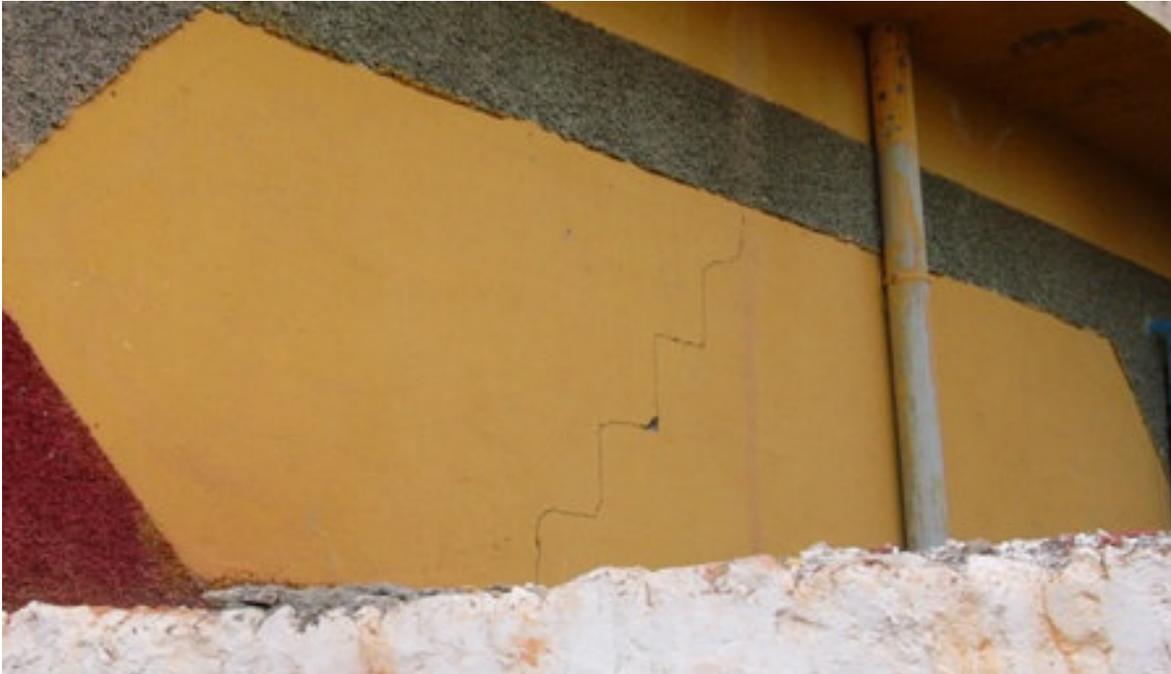
Slight shear damage to concrete block infill wall and parapet in this building in Douria. Grade 2 vulnerability C
