The Athens 19/07/2019 M_w 5.1 earthquake – Preliminary macroseismic report

In this scientific report we present the results from an in-situ campaign in the epicentral area, conducted by our research team, including macroseismic surveying of structural damage and geoenvironmental effects, while data from

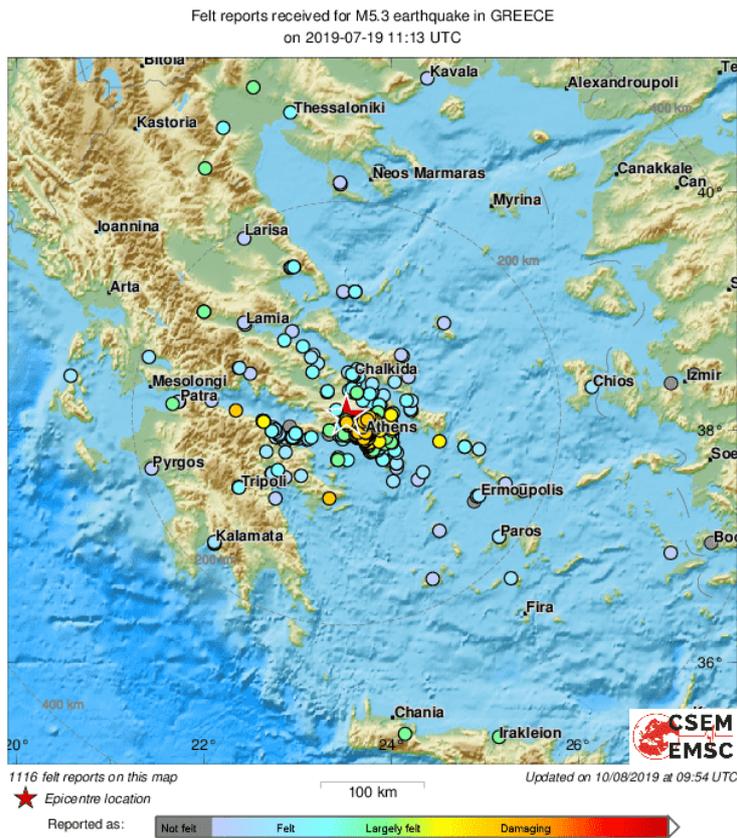
Figure 2. Map created with the testimonies provided by eyewitnesses to EMSC-CSEM (https://static2.emsc.eu/Images/INTENSITY_MAPS/78/780588/AUTOMATIC/AreaThreshold_5/EMS_98_RMW_Musson/LocMethod_PerClusterCity/DynamicClusters_MaxSize50/IntensityMapThumbnails.png)

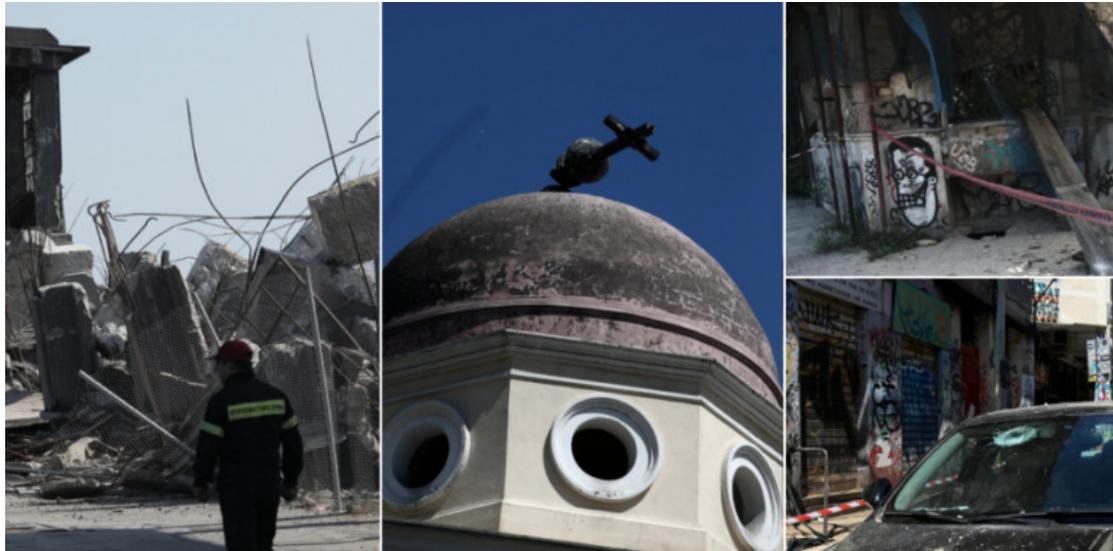
Damage due to the Athens 2019 earthquake was reported from several localities in the Attiki prefecture. In downtown Athens a couple of abandoned buildings partially collapsed and failure of non-structural elements was observed in a few others. In Piraeus port, part of an old conveyor collapsed (Photo 1). Taking into

Photo 1. Left: damage abandoned structure at the port of Piraeus. Centre: damage to the Pantanassa bell tower, Right: partial collapse to old buildings Source: iefimerida.gr - <https://www.iefimerida.gr/ellada/seismos-stin-athina-eleghoi-oi-zimies-se-foto>

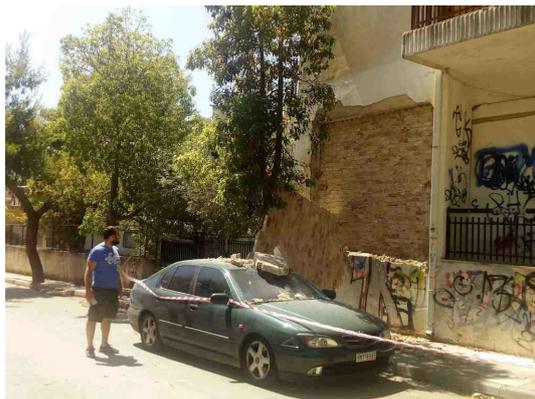
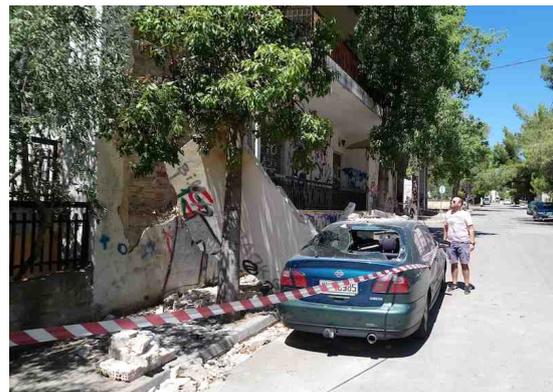
Photos 2-3: Ano Liosia

Damage was observed by the survey team from the northern and western suburbs (Photos 2-10).

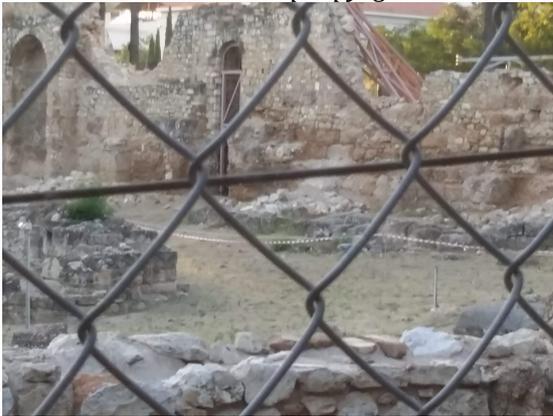
Photo 6: Dafni monastery (temporarily closed, slight non-structural damage)

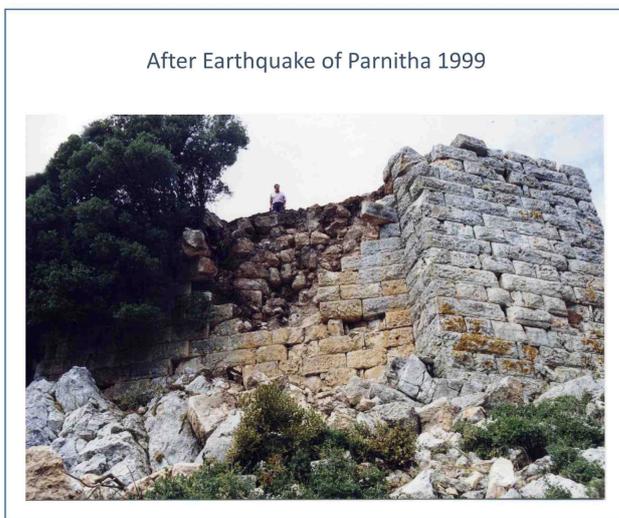
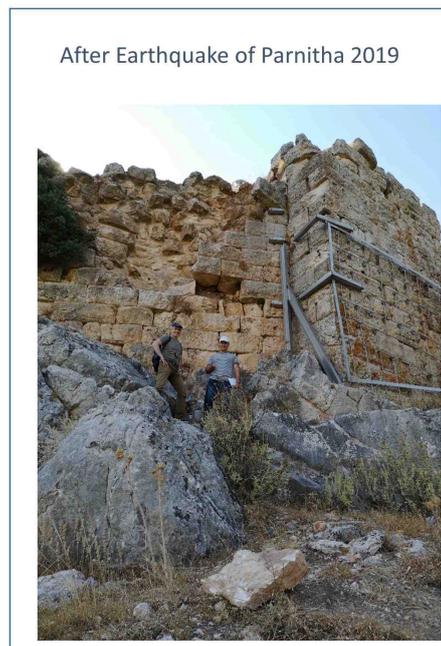
Photos 8-9: Fyli castle

A Field Investigation Team of the Institute of Geodynamics, National Observatory of Athens performed a field survey for the identification of slope failure effects (Photos 11-12). The survey found evidence of minor rock falls along the road network to the SE of the epicentre. The ancient Fyli castle was also affected with evidence of further weakening of the eastern tower–external wall of the structure. No landslides were triggered. No surface breaks were observed as was expected due to the moderate magnitude of the mainshock. Moreover, in the area north of Magoula we did not observe any bedrock scarp or outcropping fault plane.

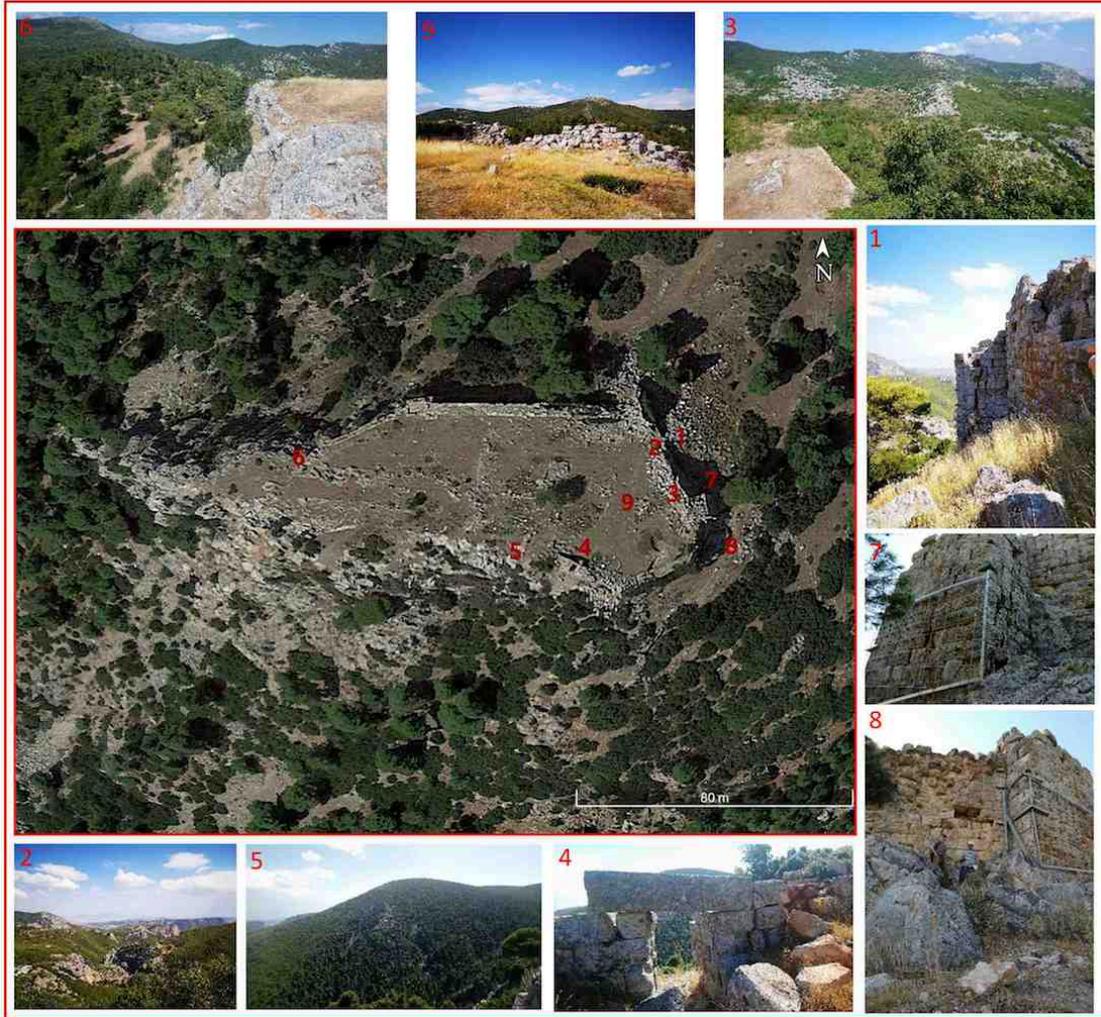
Photo 10: Fyli castle field photographs of 24 July 2019. Numbers refer to photo position round the castle (centre – satellite image by Google Earth).

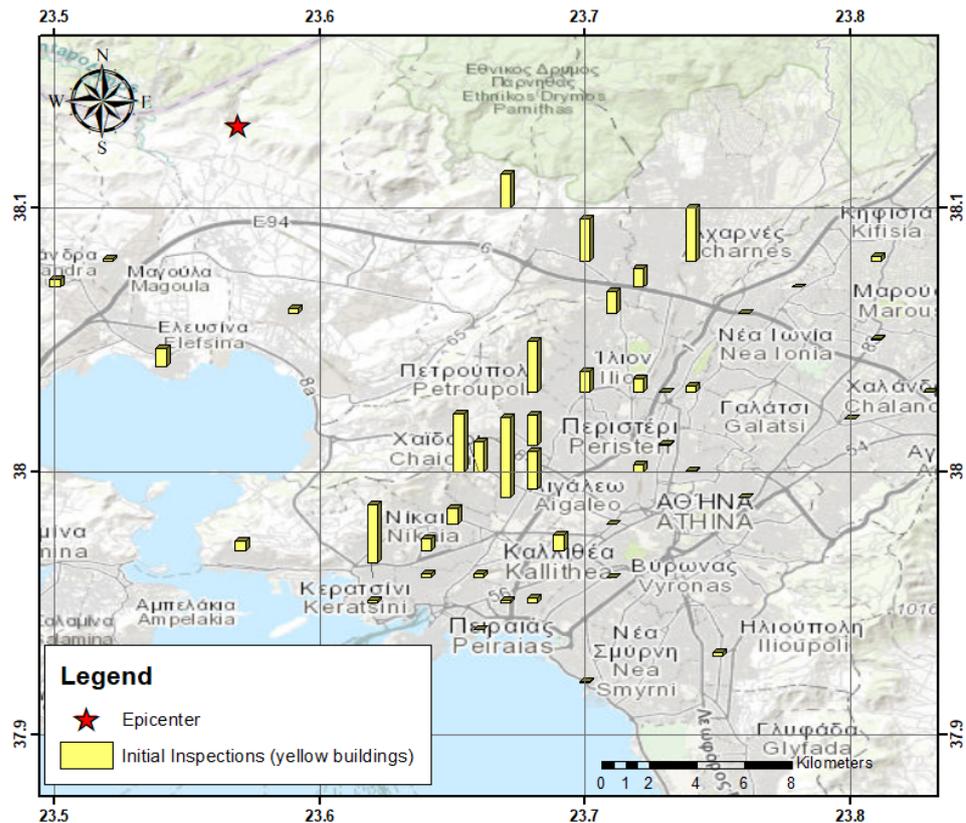
Following the earthquake, nearly 4,500 applications for building inspections were submitted to the Ministry of Infrastructure and Transport. The initial inspections performed by the teams of engineers of the Ministry’s Directorate General for Natural Disasters Rehabilitation, concluded that 821 of the buildings suffered mainly slight-to-moderate non-structural damage, characterized as temporarily unusable, or “yellow” (Figure 3), i.e. safe for users after minor interventions (EPPO-ITSAK). The final inspections results are due end of August 2019.

Figure 3. Distribution of initial building inspections per municipality. Maximum: 97 deemed temporarily unusable (“yellow”) buildings at Petroupoli municipality.

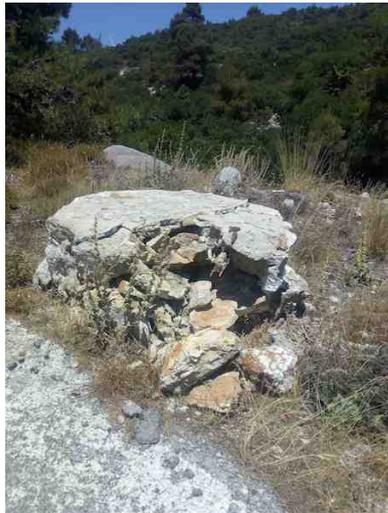
Photo 11: On the road between Ano Liosia and Fyli

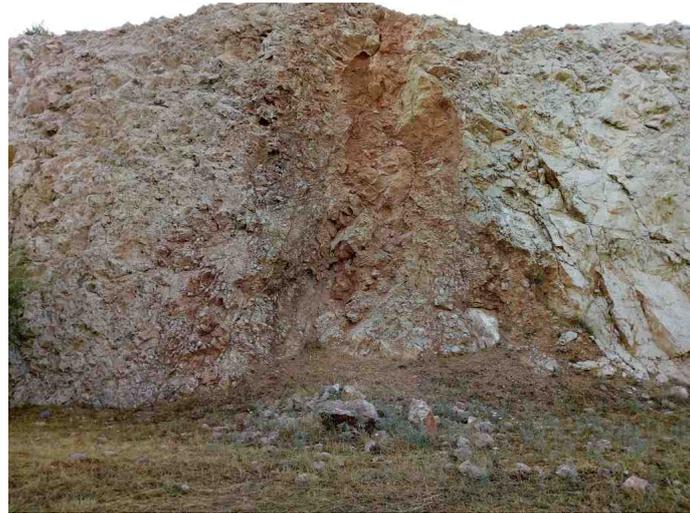
Photo 12: Aigaleo ring road

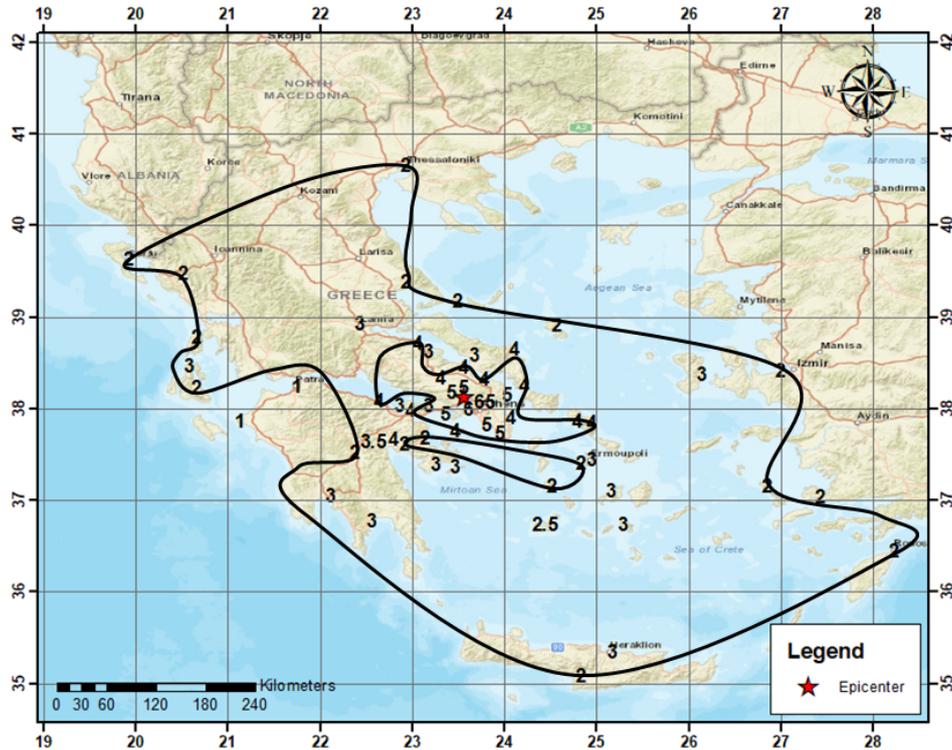
For damaged localities, intensity was estimated using the aforementioned data together with the preliminary damage inspections and collected photographic material. Slope failure observations were used for additional verification of intensity values. Figure 4 represents the assigned intensities distribution, which fall within the range 2-6/7 and the respective isoseismals for degrees 2 and 4.

Figure 4. EMS-98 macroseismic intensity distribution of the 2019 Athens earthquake and respective isoseismals for degrees 2 and 4.

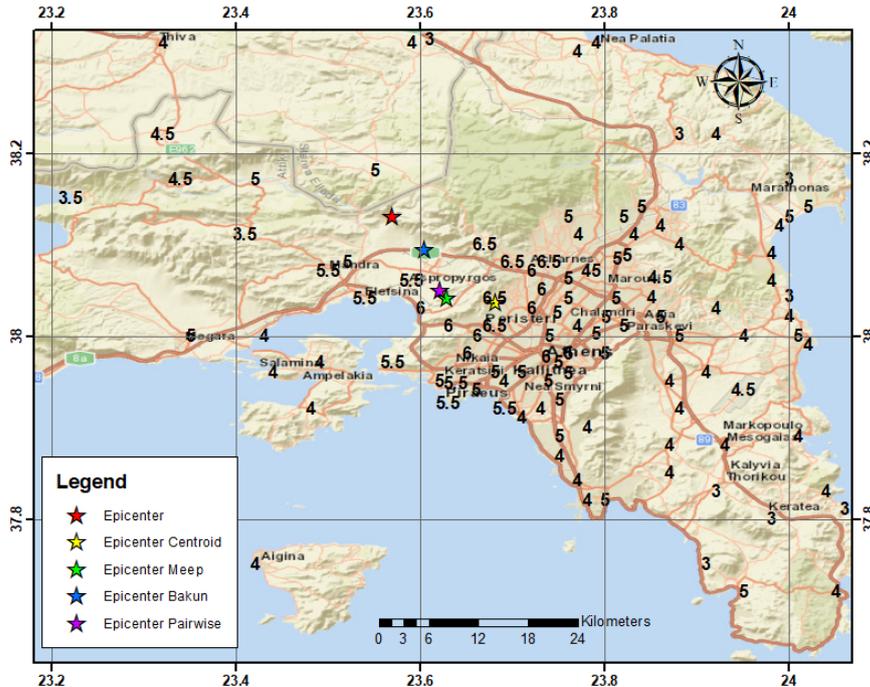
The resulting intensity data was used as input for independent macroseismic parameters estimation. We applied the MEEP package developed by Musson and Jimenez (2008), with the coefficients estimated by Kouskouna et al. (2019, in press) for the area of Greece. The results of the 4 methods used in MEEP package (Centroid, MEEP, Bakun, Pairwise) for epicentral coordinates, equivalent moment magnitude and focal depth, accompanied by their uncertainties, are presented in Table 3. An overestimation of the instrumentally-determined moment magnitude by 0.3 units (except for the Bakun method) is observed, taking into account the sensitivity of the methods with regard to all intensity levels distribution. Slight changes are expected with the final intensity dataset. Finally, Figure 5 shows the distribution of instrumental and macroseismic epicentres and EMS-98 intensity distribution in Attiki area. All macroseismic epicentres from the 4 MEEP package methods are shifted to SE with respect to the instrumental determination.

Figure 5. The 2019 Athens earthquake EMS-98 intensity distribution in Attiki area and associated instrumental (red) and macroseismic epicentres.

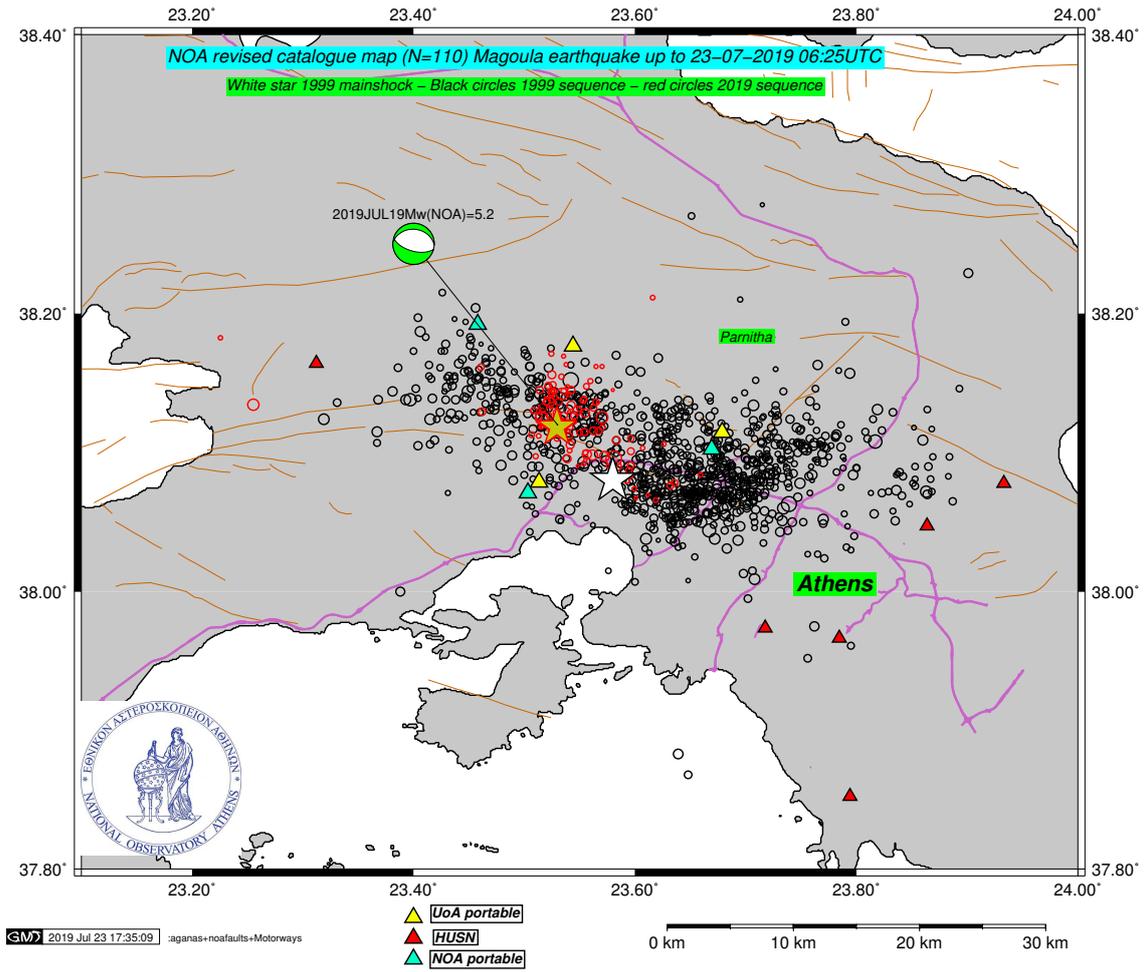
The relation of the 2019 to the 1999 event is apparent through their aftershock sequences distribution (Figure 6). The area covered by the 2019 aftershocks (red dots) is considerably smaller, indicating that the activated western fault segment is smaller than the 1999 eastern one. The 4-day aftershock distribution (110 events) is clustered around the mainshock, and mostly towards the north. A smaller cluster formed a few km to the SE of the mainshock.

Figure 6. Aftershocks distributions of the 2019 and 1999 Athens earthquakes

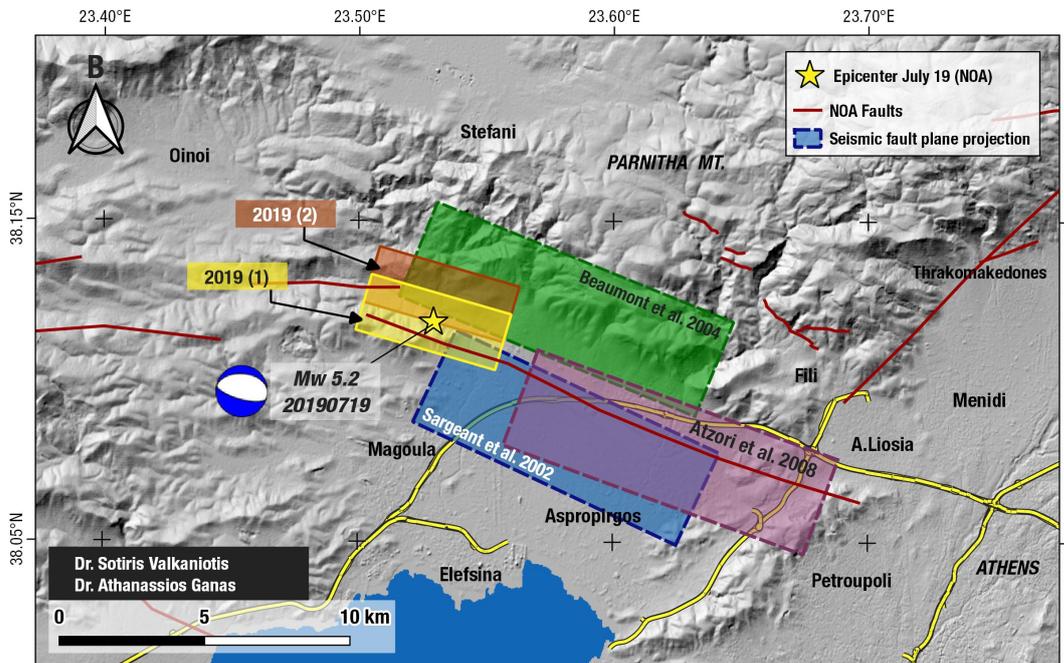
A preliminary fault model indicates that a rectangle of 6 km (long) by 4 km (wide) may fit the seismic source. The orientation of the source is ESE-WNW (N106°E) and the dip-angle is 60° towards south. This geometry resembles greatly the 1999 seismic source (Atzori et al. 2008), thus it is possible to consider the 2019 source as the western continuation of the 1999 event. In this preliminary study we need to consider both options concerning the position of the 2019 fault plane inside the crust, i.e. that the mainshock originated in the slip centroid (model 1) or from the bottom end of the fault with the rupture growing updip (model 2). The respective solutions are presented as surface projections of the two fault segments in Figure 7.

Figure 7. Seismic fault plane surface projections solutions for the 2019 and 1999 Athens earthquakes
