Field report for the December 2004 earthquakes in Nador, Morocco.

Patrick Murphy Corella Architect, Calle Piamonte 18, 28004 Madrid, Spain +34 696 22 69 73
alhaquen@tiscali.es

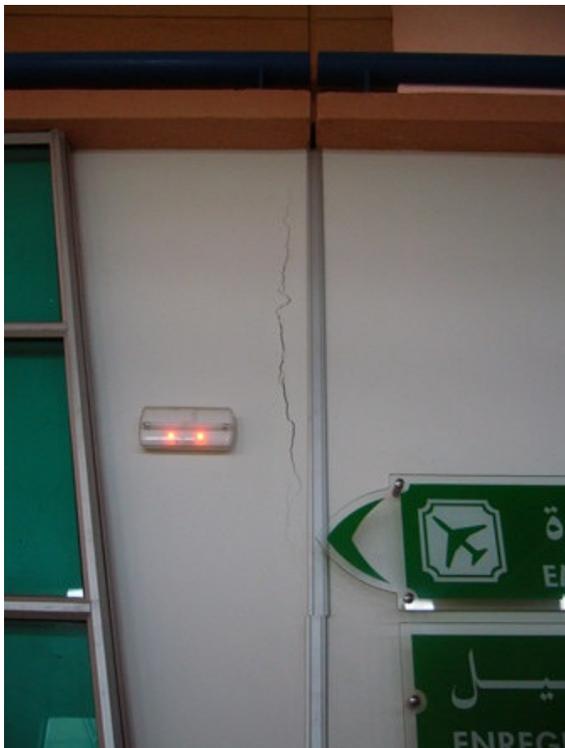
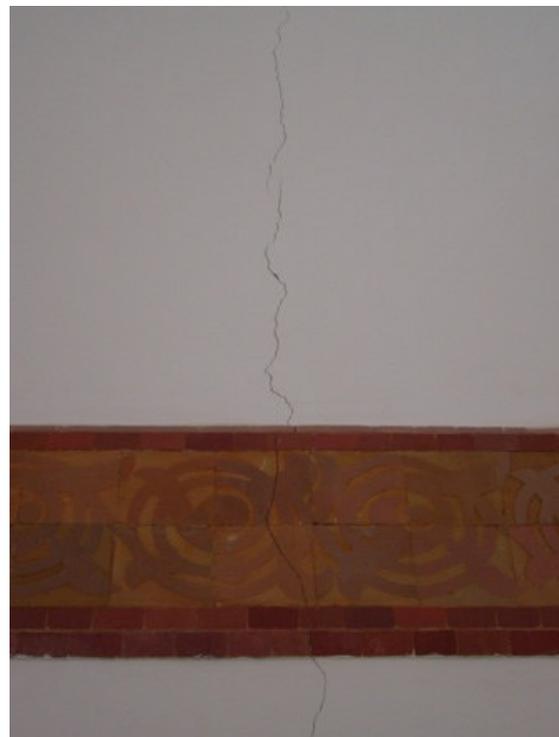
Very slight shear damage to walls and finishes in Nador Airport. Crack below left is cosmetic pounding damage to one side of an expansion joint. Grade 1 or 2 vulnerability D.
